DEVELOPMENT OF CABLE MATERIAL: IMPROVED WIRE ALLOYS FOR AIRCRAFT  
ARRESTING DECK PENDANTS

Richard L. Jentgen  
Richard C. Rice  
Curtis M. Jackson  
Gregory A. Fuller  
BATTELLE  
Columbus Laboratories  
Columbus, Ohio 43201

Final Report

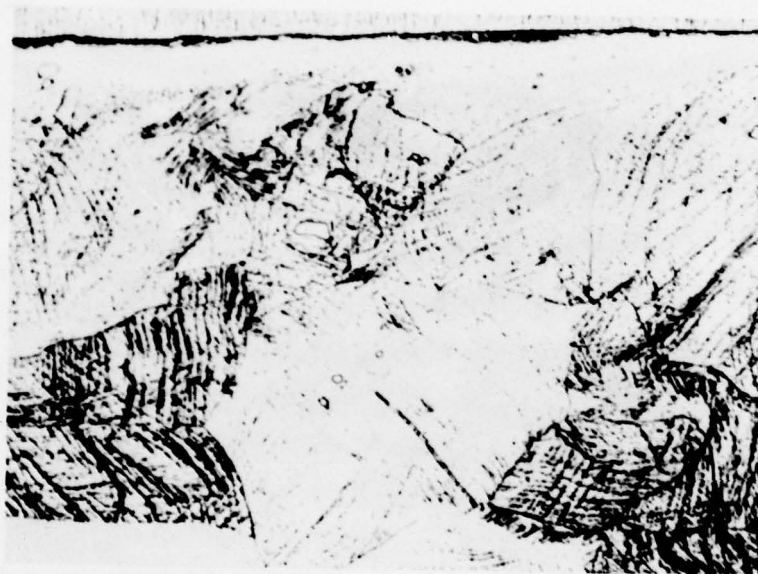
FIGURE 16. THE ABRADED INCONEL 718 WIRE

a. Longitudinal and Transverse Sections of the Abraded Wire Show the Interesting Precipitate-Outlined, Cold-Worked Structure

b. Note the Small Affected Zone

FIGURE 16c. THE PARTIALLY SOLUTION-TREATED ABRADED ZONE  
(Some precipitates can still be seen in the abraded region.)

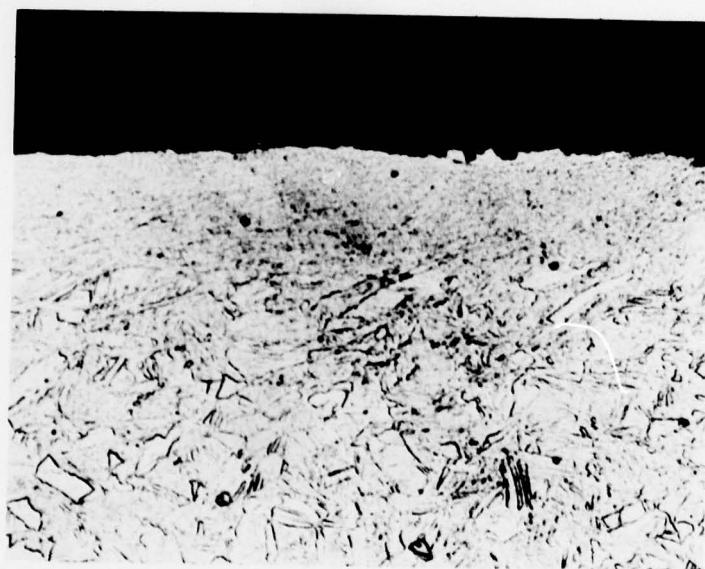
FIGURE 17. THE ABRADED MP35N-ALLOY WIRE

Figure 17 shows photomicrographs of a transverse section from an abraded MP35N wire. The microstructure typical of this alloy in the regions unaffected by the abrasion was a face-centered-cubic, solid-solution, primary phase with a significant amount of a transformed hexagonal structure formed from the cold work during wire drawing. The hexagonal structure cannot be seen with a light microscope.

The abrasion-affected zone shows a partially solution-treated material having a very fine structure. Apparently, the very small affected zone had been heated to a high temperature, but the temperature did not significantly degrade the mechanical properties of the wire.

a. Transverse Section of the Abraded Wire
